TECHNICAL BULLETIN 012

31/03/2006

VAG 1.9 D / SYNCHRONOUS DRIVE / INSTALLATION INFO

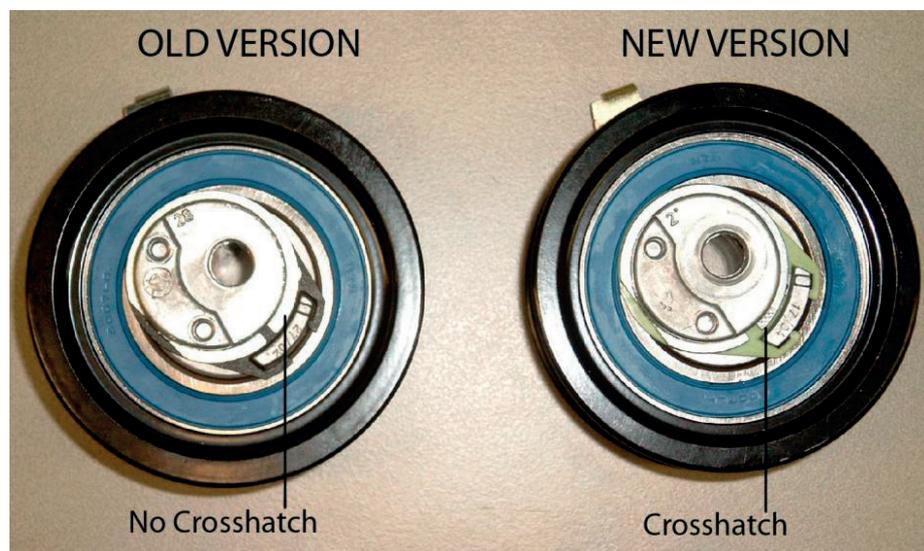
FIG. 1

In Fig. 1 you can see that only the new version has a crosshatch belt wear indicator (see also Fig. 4). This section indicates when the timing belt is worn out and when it needs replacement.

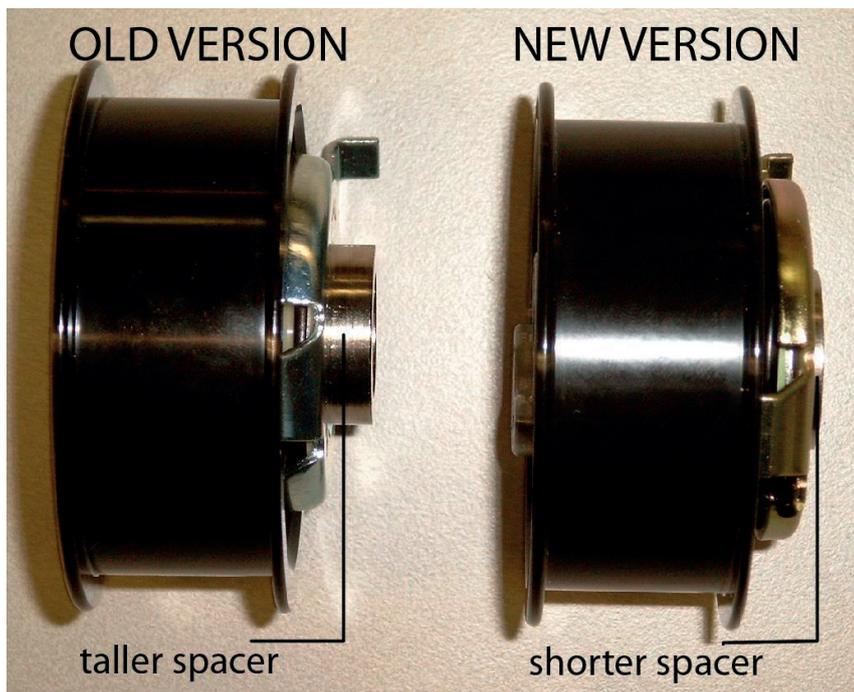
FIG. 2

In Fig. 2 you can see that the new tensioner also has a shorter spacer. However, the distance between the engine block and the pulley remains the same.

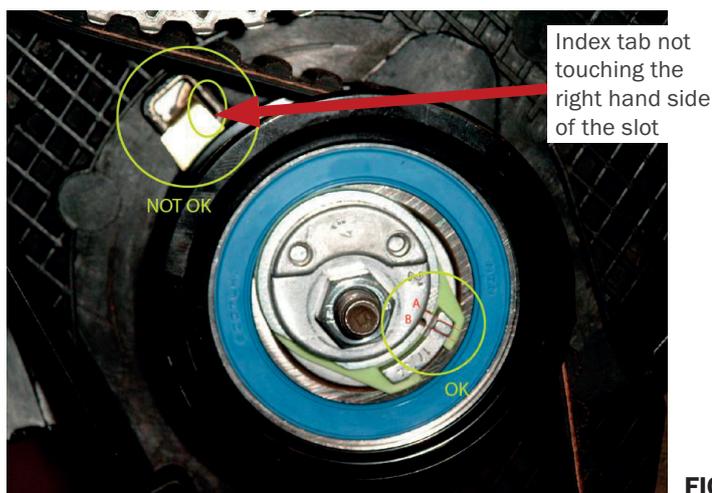
FIG. 5

Fig. 5 shows one of the common errors. Pointer is perfectly positioned between lines A and B but the index tab is not OK. The index tab is in the slot but is not pushing against the right hand side of the slot. The reason for this is that the tensioner was moved anti-clockwise during the tensioning process.

If the pointer is not well positioned, the mechanic should restart the tension-setting procedure completely.

When you are in the tension-setting, never turn the tensioner anti-clockwise!

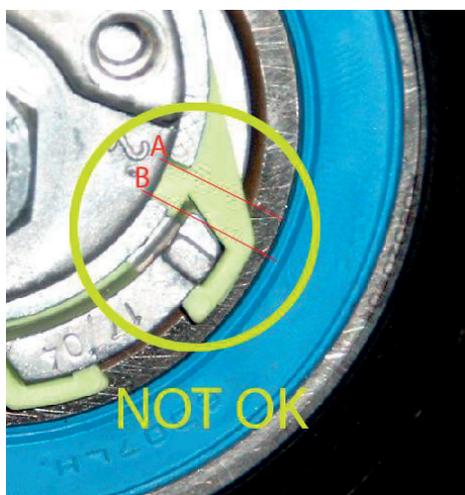
FIG. 7

A third installation error is shown in Fig. 7. The pointer has passed line B, this means that the belt will be tensioned too much.

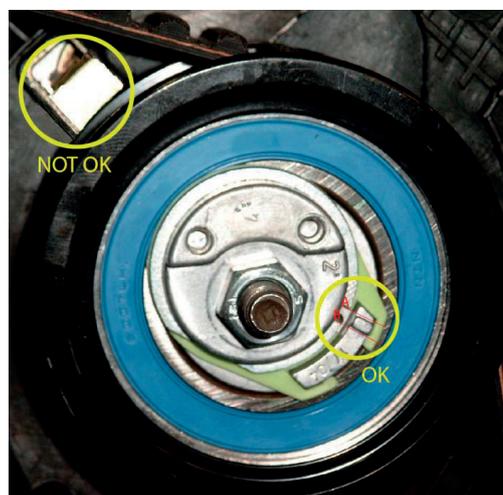
FIG. 8

In Fig. 8 you can see a fourth error where the index tab is not locked in the slot although the pointer is perfectly positioned between lines A and B. This way the belt will lose its tension once in operation.

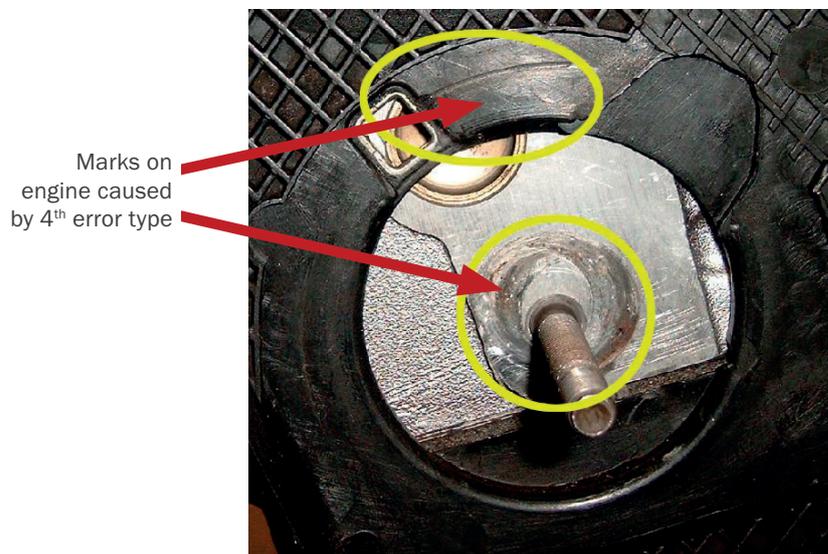
FIG. 9

You can see the marks on the engine caused by this type of wrong fitment in Fig. 9. In this case you will also see that the index tab on the tensioner is slightly bent over.

When the vehicle is released with a wrong positioned tensioner, severe engine damage will happen sooner or later.

We can't stress enough how important it is to follow all the steps in the process of installing this tensioner without skipping one of them. It is better to lose 5 minutes at the installation than to lose an entire engine in the end.
