23/10/2008

# GM 1.7D (ISUZU) / SYNCHRONOUS DRIVE / TENSIONER INFO

This Technical Bulletin replaces Technical Bulletin N° 009.

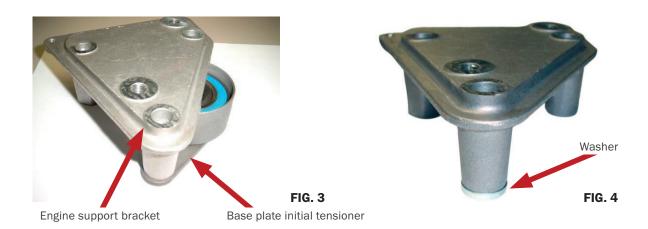
As the initial tensioner base plate was fitted under a leg of the engine support bracket (Fig. 3), K015563XS can only be used from engine nr 328704 on.

K025563XS is supplied with a washer to compensate the lost thickness of the base plate under the shorter leg of the early engine support bracket as in Fig. 4, and contains a stud which is needed to hook the new tensioner spring on (Fig. 5). This K02 can always be used: up to engine nr 328703, using the washer and the stud; and from engine nr 328704 without the washer and the stud.

K035563XS is supplied with the new OE engine support bracket, with 3 legs of the same length. This kit can be used up to engine nr 328703.
