## VAG 1.9, 2.0 TDI / ACCESSORY DRIVE / INSTALLATION INFO

**GATES REFERENCE:**  
T38306 & related kits.

**MODEL:**  
A4, A6, Bora, Golf, Passat, Superb.

# TECHNICAL BULLETIN 031

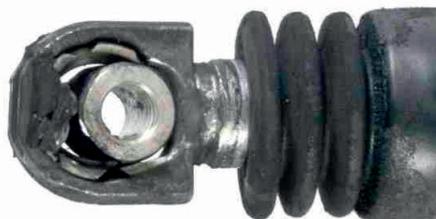
FIG. 2

An Overrunning Alternator Pulley (OAP) which is not working properly will create even more belt vibrations and noise. This can lead to excessive wear of the fixing hole at the top of the hydraulic actuator. (Fig. 2)

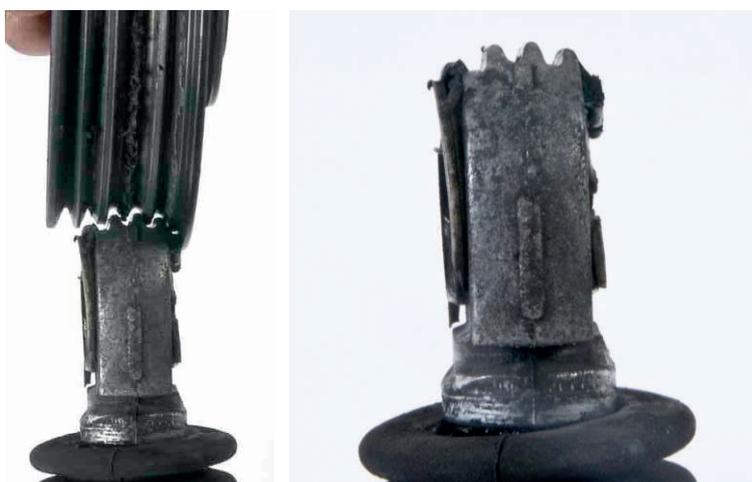
FIG. 3

This play can become enormous, leading to the tensioner body touching the tensioner pulley, causing a lot of noise. In its extreme form the tensioner body will even get grooved, because the pulley is “grinding” it. (Fig. 3)

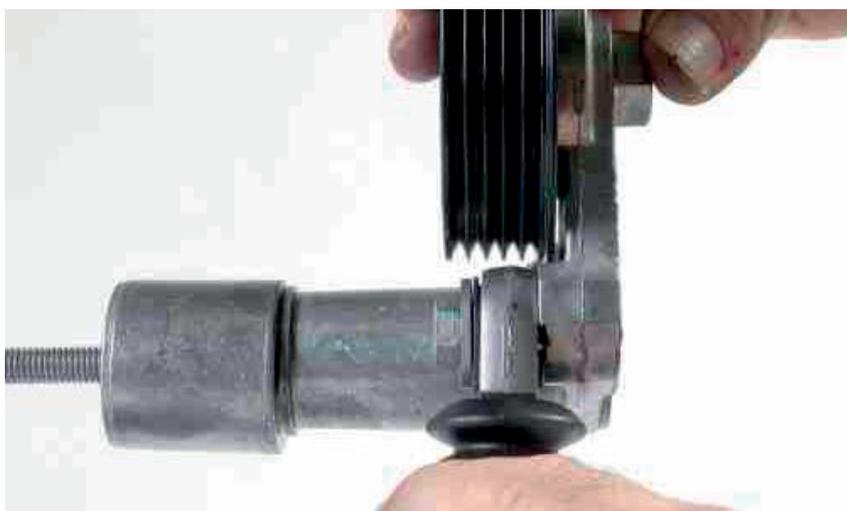
FIG. 4

In new condition, the free space between pulley and tensioner is 5 mm. (Fig. 4)

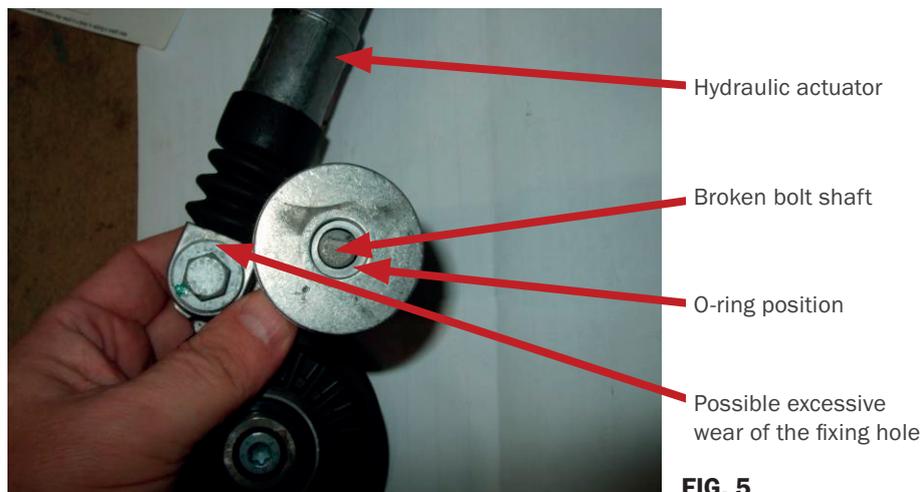
FIG. 5

It is therefore essential that the complete drive is checked regularly. We recommend replacing the belt, tensioner, OAP and TVD at the same time. Also the installation torque of the tensioner mounting bolts is critical. Failure to apply the correct torque will usually lead to the central mounting bolt shearing (Fig. 5).

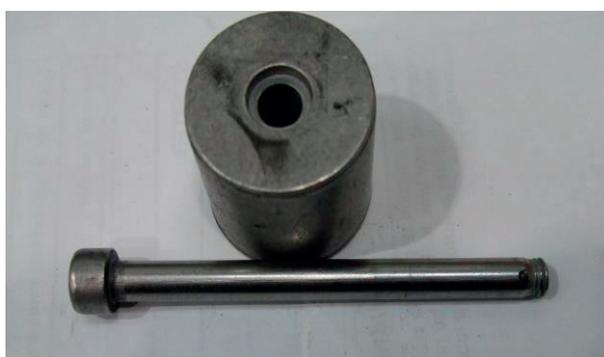
**FIG. 7**

If the mounting bolts are too tight it will distort the mounting bushing, preventing the hydraulic actuator to pivot on the mounting bolt. All forces are therefore transmitted to the central mounting bolt, which eventually shears. A too low torque on the central bolt will lead to the load/vibrations being absorbed by the bolt shaft, also resulting in a bolt rupture (Fig. 7).
