TECHNICAL BULLETIN 033

31/12/2009

RENAULT 1.4 & 1.6 16V / SYNCHRONOUS DRIVE / INSTALLATION INFO

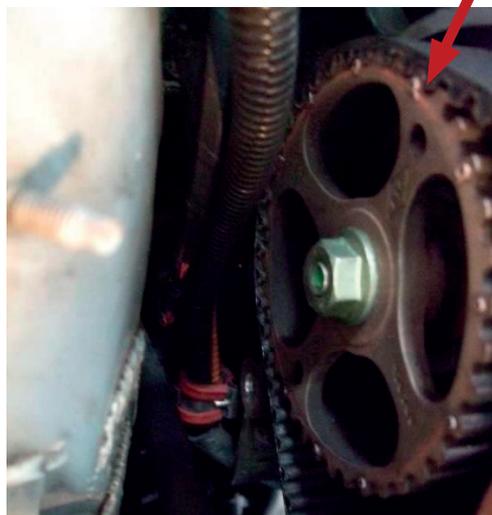
FIG. 1

In this drive, excessive play from the water pump bearing often occurs, this leads to belt tracking forward and forces the camshaft pulley flanges to detach and possibly enter the drive system. The result is belt failure.

Also earlier mechanical damage to the flanges can lead to this (Fig.1). The camshaft pulley design has changed on these engines (but the OE ref. remained the same), in order to prevent this failure mode.

Flange detached

We always recommend servicing with a complete water pump kit. While changing the water pump, make sure the correct bolts/washers are used and torqued correctly.

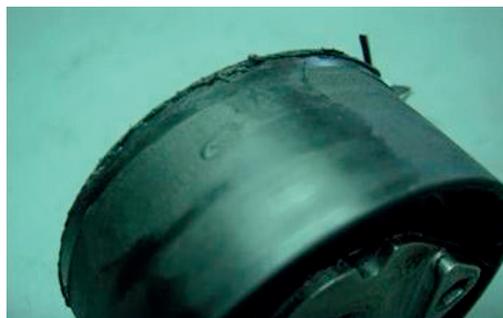
FIG. 3

Rubbing mark

Incorrect part or bolt coming loose leads to tensioner pulley contact (Fig. 3).

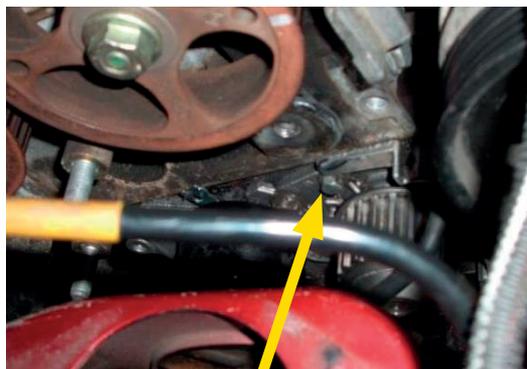
FIG. 4

While installing the new idler pulley, ensure that the spacer (sitting between the old pulley and the engine block) is re-fitted between the new pulley and the engine block. If not, the idler pulley can touch the water pump, causing idler and belt failure (Fig. 4 and 5).

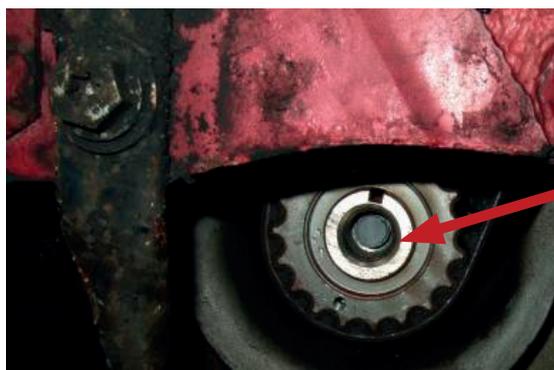
FIG. 6

The crankshaft bolt can't be re-used. (OE ref. is 8200557644. This is supplied with the kit). The correct torque setting of this bolt is very important and varies per engine code or model. Incorrect torque causes bolt shear. (Fig. 6)

Bolt sheared

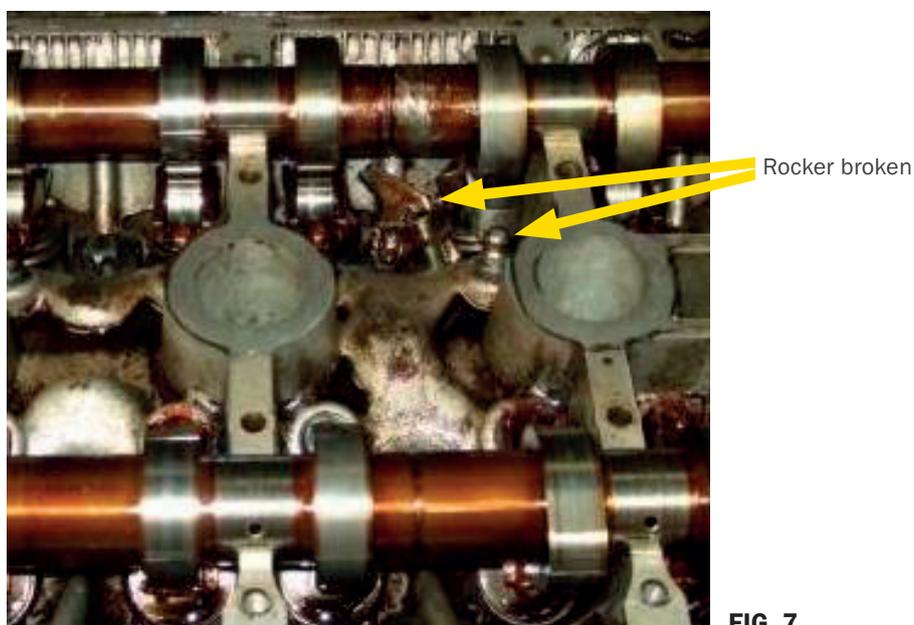
**FIG. 7**

In the event of an engine repair, after piston to valve contact, a close inspection of the camshaft rockers is essential. It is possible that rockers sustained damage. If so, the rockers must be replaced. Neglecting their replacement causes seizing of the camshaft. (Fig. 7)

It is recommended to use installation tool kit (GAT4960) to service this drive.
