TECHNICAL BULLETIN 045

23/12/2011

TENSIONER / KIT INSTALLATION ON PSA DIESEL ENGINES

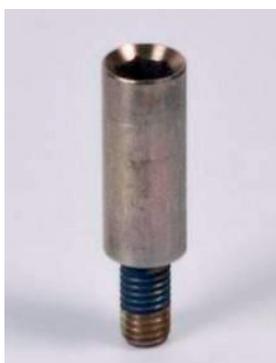
ZDJ. 1

We've found several cases where the tensioner pulley was not positioned correctly over the mounting stud (Fig. 1).

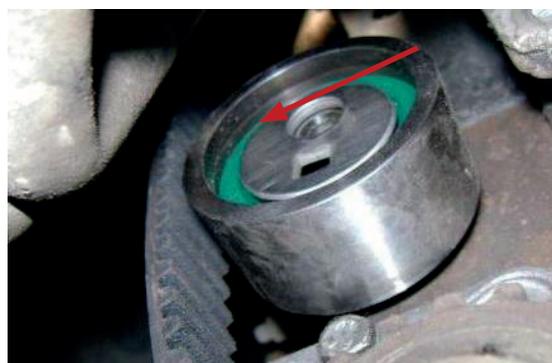
ZDJ. 2

This misalignment will cause the belt to track, leading to engine failure.

If the inside of the tensioner front plate rests against the front edge of the mounting stud (Fig. 2 and 3), this results in the tensioner pulley not sitting straight over the stud even after the fixing bolt (Fig. 4) is installed with the correct torque. This will lead to belt misalignment, resulting in a premature failure.

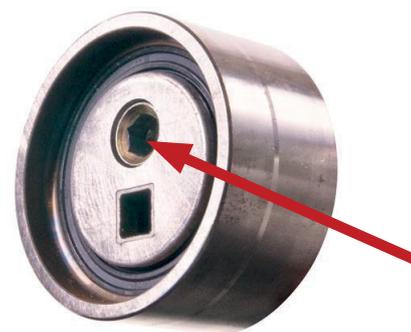
ZDJ. 5

Fig. 5 shows the correct tensioner on stud position.

Important: Engine must be at ambient temperature.
We advise to replace the water pump together with the belt.
