TECH TIP 009

E2/TT009 v1.0
2014/12

OAP7144

OPEL & VAUXHALL 1.4 PETROL

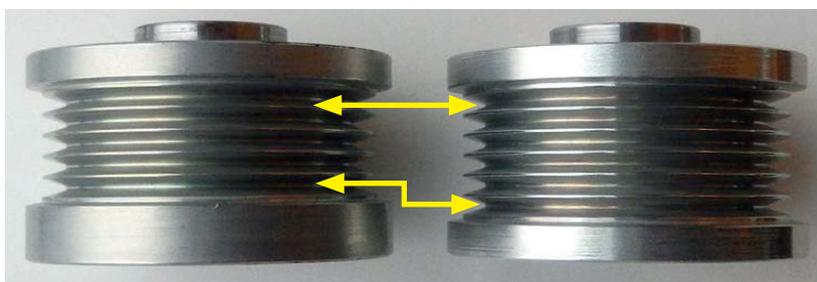
FIG. 1

On certain Opel/Vauxhall engines (codes: A14NEL, A14NET, A14XEL, A14XER) the belts may have 5 or 6 ribs while the pulleys may have 5 or 6 grooves. It depends on the manufacturing date of the car. Gates recommends replacement of a 5 groove OAP (Fig.1 left side) with the 6-grooved OAP7144 (Fig. 1 right side).

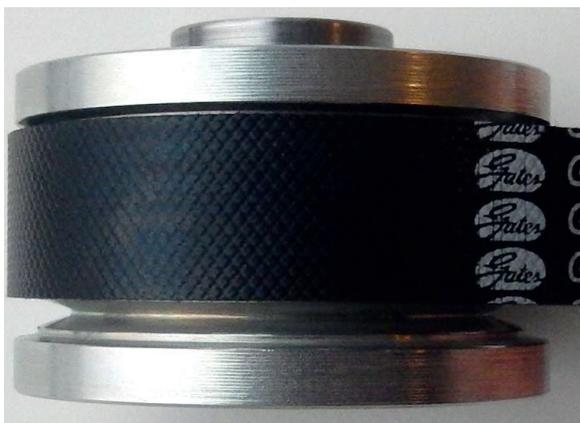
FIG. 2

If the belt is not placed correctly on the OAP like this, severe misalignment occurs, which may cause premature failure.

If a belt with 5 ribs must be installed on to OAP7144 (Fig. 2), the outer groove (away from the engine) must be left open.

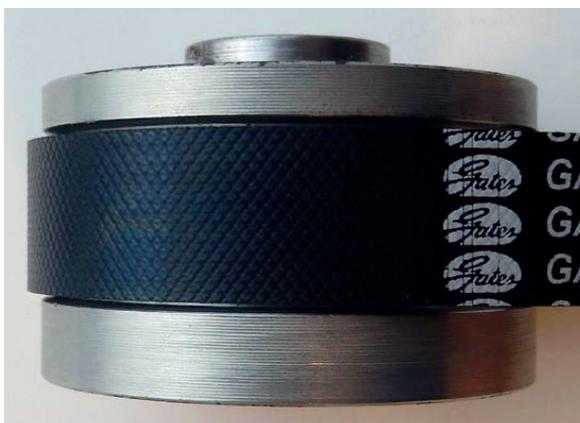
FIG. 3

Fig.3 shows an OAP with 5 grooves that must be replaced by the 6-grooved OAP7144.
