TECHNICAL BULLETIN 041

23/12/2010

VAG 1.9 D / ACCESSORY DRIVE / TENSIONER INFO

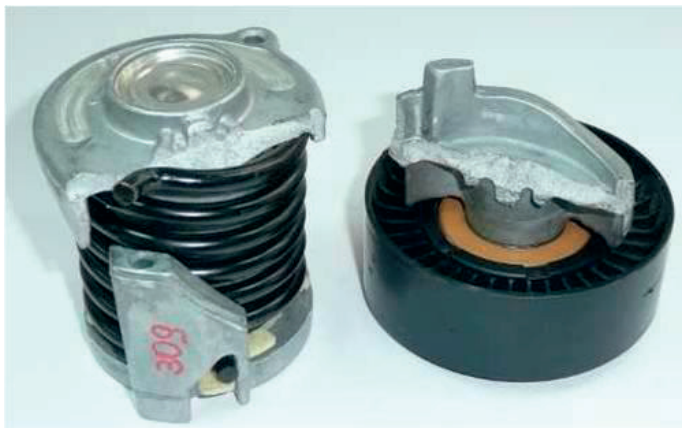
**FIG. 3**

- Worn Overrunning Alternator Pulley
- Solid pulley installed instead of an OE prescribed OAP
- Using an OAD (Overrunning Alternator Decoupler) instead of an OWC (One Way Clutch)

In all these cases where the OAP did not perform as it should, the hydraulic tensioner element had to cope with abnormal vibrations in the drive; leading to earlier prescribed bracket material fatigue.
(Fig. 3)

- The OAP is a wear item, which has to be checked regularly for proper functioning.
- Replace the alternator pulley only with the prescribed Gates part.
- Follow OE recommended installation procedure.
- Replace all service parts in the drive, use the complete kit.
