TECHNICAL BULLETIN 026

17/11/2008

SOFIM 2.4, 2.5, 2.8 DIESEL / SYNCHRONOUS DRIVE / INSTALLATION INFO

GATES REFERENCE:
5039, 5113, 5334XS, 5335XS,
5495XS & related kits.

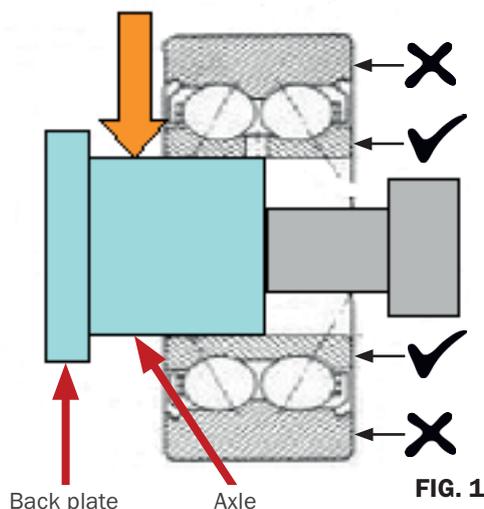
- Always remove rust or remaining grease from the axle/back plate before assembly (orange arrow). If you fail to do this, you will push all the dirt to the bottom of the back plate creating a build-up of debris, which will damage the bearing due to misalignment or create an incorrect tightening torque.
- Always install the bearing by pushing on the centre part of the bearing (✓)
- Never **force** the idler over the axle by pushing on the outside of the bearing (✗). (Fig. 1 and Fig. 2)

This would lead to misalignment of the bearing and cause an idler brake-down. It also could lead to the seal coming loose, causing loss of grease and dirt penetration into the bearing.

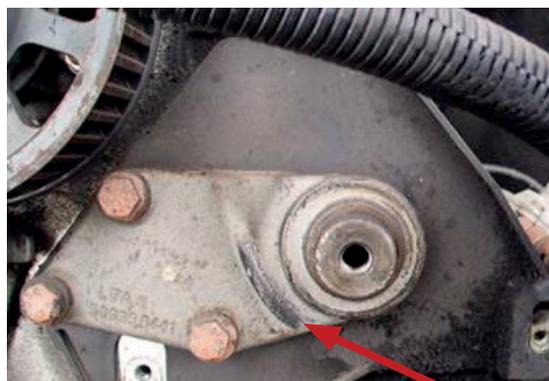
Misalignment will also lead to the belt coming in contact with the back plate. This will leave a rubbing mark on the back plate (Fig. 3).

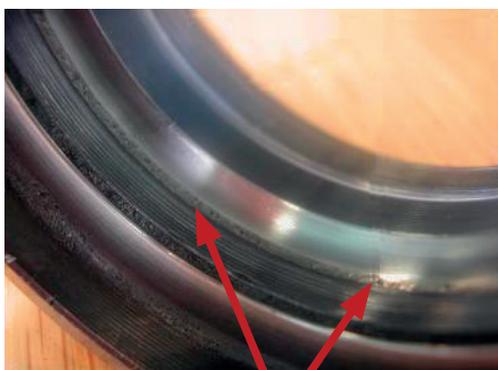
FIG. 4

Fig. 4: The bearing balls rolling outside their track due to misalignment and incorrect torque setting.

Ball traces

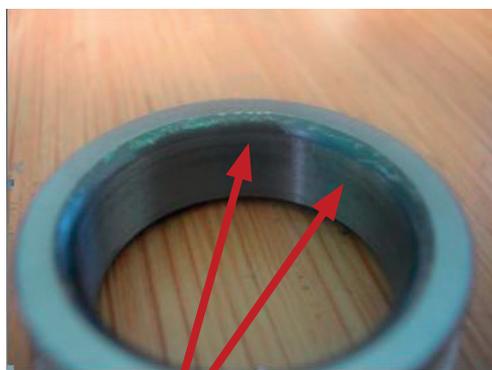
FIG. 5

Fig. 5: Abnormal rotation of the interior rings through incorrect tightening.

Abnormal rotation traces

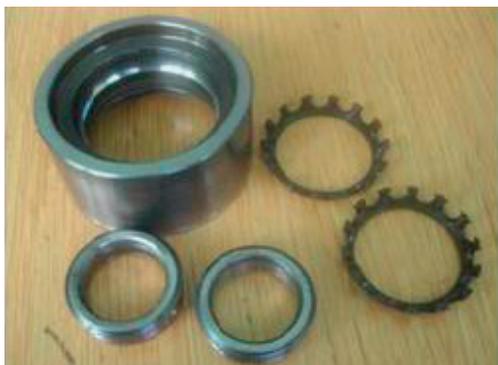
FIG. 6

Fig. 6: A too low tightening torque will lead to the bearing falling apart.

- Always check the play between the axle and the bearing. If there is excessive play, replace axle/back plate.
- Always apply the OE recommended tightening torque; it is very important as it determines the preload of the bearing.
- Always use fixing glue in order to avoid the bolt/nut coming loose due to vibrations and thermal expansion/contraction of the different metal parts (if the bolt/nut loosens, the bearing falls apart) (See Fig. 6).

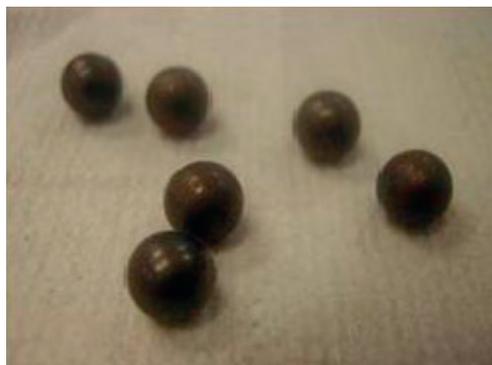
FIG. 7

Fig. 7: Deformation of the bearing balls because of excessive temperature, resulting from too high tightening torque.

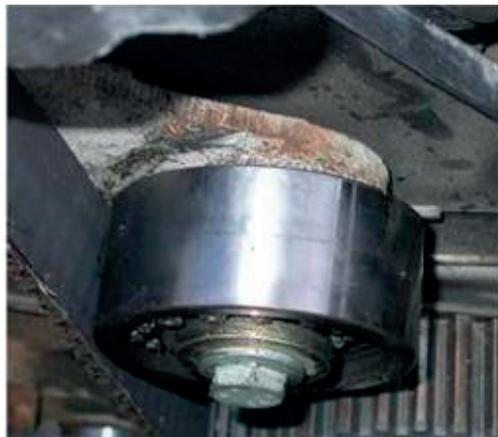
FIG. 8

Figure 8: The seal has come out of the bearing and the ball cage has been completely destroyed.

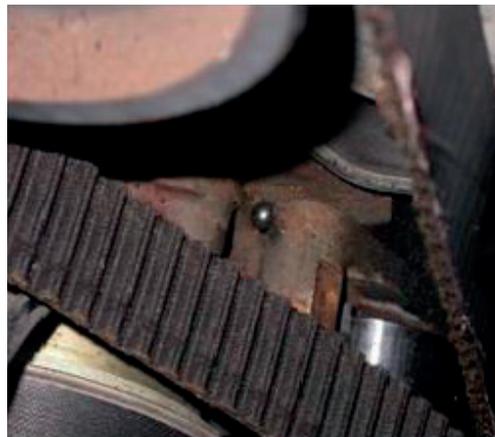
FIG. 9

Figure 9: This results in bearing balls in the lower engine compartment. Remove all possible debris from the drive system.
