TECHNICAL BULLETIN 027

29/04/2009

FORD 1.8 D / SYNCHRONOUS DRIVE / INSTALLATION INFO

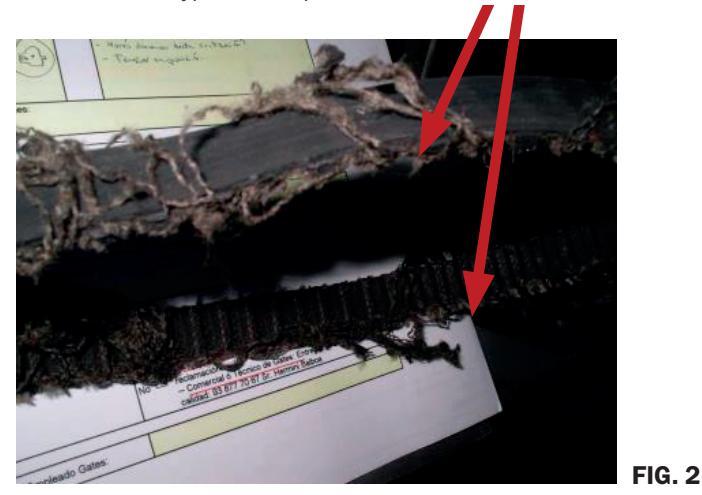
Failure to do all the above will lead to wrong tension, with possible tracking of the belt as a result. The belt will climb over the camshaft sprocket flange, running into the timing cover (Fig. 2 and Fig. 3).

Typical wear pattern of the side of the belt

- 7) Torque the tensioner bolt (50 Nm) while holding the tensioner in place.
- Torque the camshaft bolt (50 Nm) while holding the sprocket in place. Use Gates sprocket holding tool GAT4844. 8)
- 9) Remove the camshaft and crankshaft locking tools.
- **10)** Turn the engine nearly 6 revolutions by hand.
- **11)** Re-insert the crankshaft pin; rotate the engine further till TDC.
- **12)** Check the tensioner indicator position, if not in the middle of the slot, restart the tension setting procedure.
- **13)** Insert the camshaft locking tool (at the back of the engine). If not possible, restart the tension setting procedure.

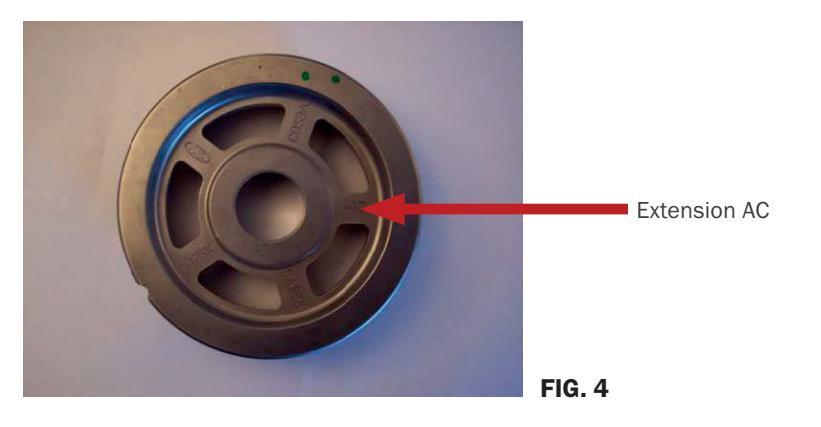
Check if the part number of the camshaft pulley ends with **AC** (Fig. 4). In case the part number of the camshaft pulley ends with **AB**, fit a new sprocket with OE ref. XS4Q6A256**AC**.

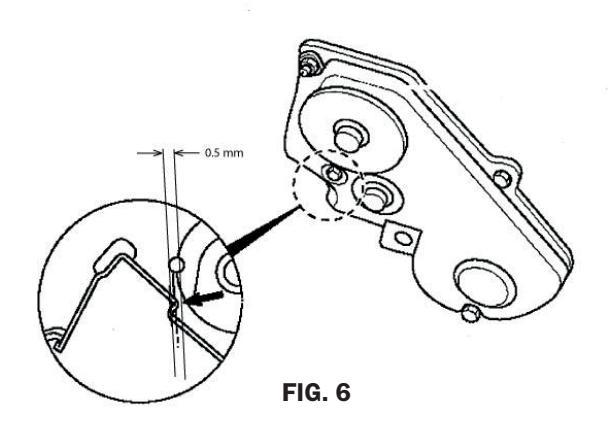
When the manual tensioner is replaced by an automatic tensioner, the timing belt cover has to be slightly modified.

File off the inner corner (0.5 mm) as shown in Fig. 6.

Do not damage the timing belt cover by filing off too much of the corner!
