# TECHNICAL BULLETIN 039

## MULTIPLE / ACCESSORY DRIVE / TORSIONAL VIBRATION DAMPER (TVD)

**GATES REFERENCE:**  
ALL TVD.

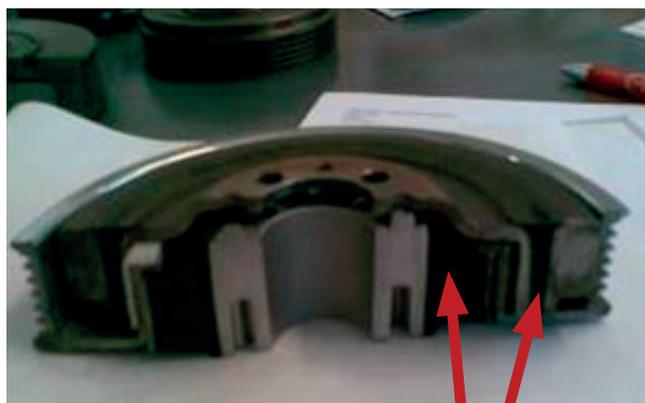
FIG. 1

It is important to dampen these excessive vibrations. To protect the gearbox and drivetrain a dual mass flywheel is often used. The Front-End Accessory Drive is protected by the Torsional Vibration Damper (TVD). A TVD is a crankshaft pulley in which a rubber element connects the 2 main metal parts (Fig. 1).

Rubber element

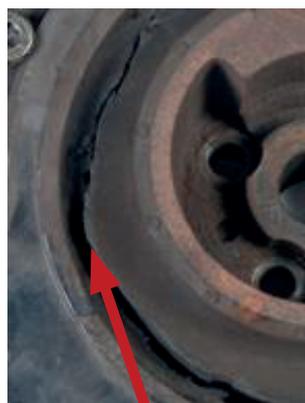
FIG. 2

This connecting rubber functions as the damping element. Because of its material (rubber) and its purpose (damping vibrations), it wears out and will need replacement after a certain time (Fig. 2).

Cracked rubber

1. Cracks in the rubber (Fig. 2)
2. Parts of rubber missing (Fig. 5).
3. Clear contact marks from metal "indicator" in slotted holes (Fig. 6)
4. Some TVD's will show rust particles on the outside as an early warning
5. A Micro-V® belt running out of the pulley (Fig. 7) could be the result of a faulty TVD

- The TVD should be replaced when the ABDS belt and tensioner are replaced. We recommend to change it no matter what after 100.000KM
- At each service after 30.000 km, especially after a car crash, the TVD has to be carefully checked for signs of wear or damage. In most cases wear/damage is visible on the backside of the pulley sooner than on the front side.
- The wear will not always show, but TVD or belt noise is proof of a problem.
- In order to guarantee the optimum performance of the TVD, it should be installed according to the manufacturer's recommendations.
- Many TVD's are bolted on the engine with stretch / elastic bolt(s), which need to be replaced after removal, **fitted to the correct torque (incl. angle if instructed)!**

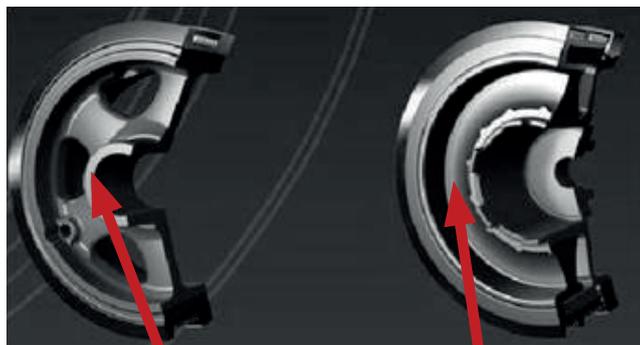
FIG. 3

Open type

Closed type

There are 2 main types of TVD's. The "open" type for petrol engines mainly, and the "fully closed" type for diesel engines mainly (Fig. 3).

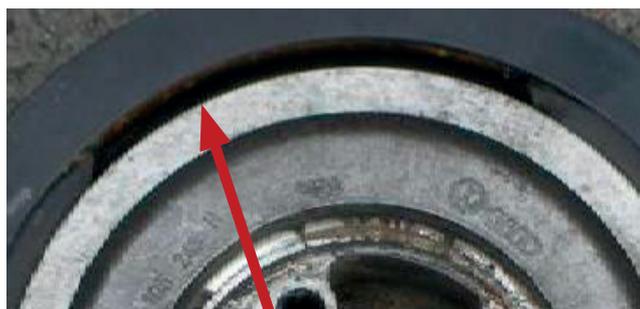
FIG. 5

Missing rubber

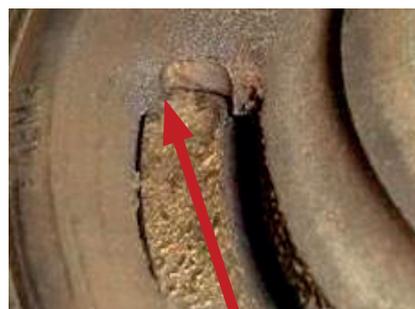
FIG. 6

Damaged slotted hole

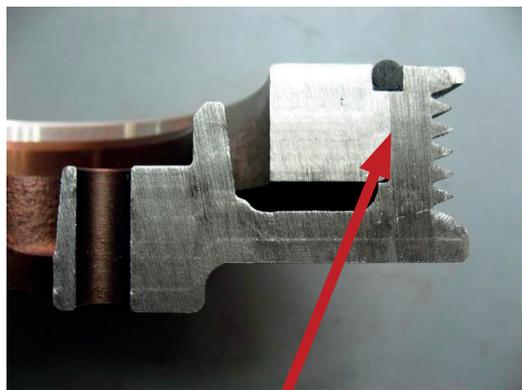
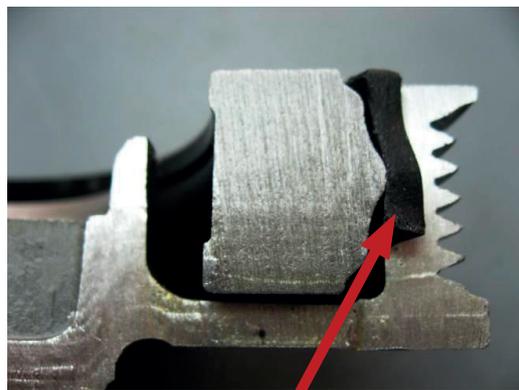
FIG. 8

No damping rubber, only outside O-ring

Rubber damping element

- 1) Idling speed as well as sporty driving is the worst conditions for TVD's and other drive components.
- 2) TVD's should not be used without an accessory belt installed!!!
- 3) Watch out for fake TVDs (Fig.8)! These cheap pulleys are not having any damping function at all, as there is no rubber element inside; only a rubber O-ring on the outside.
