TECHNICAL BULLETIN 014

24/04/2006

FIAT 1.6 PETROL ENGINES / SYNCHRONOUS DRIVE / TENSIONER INFO

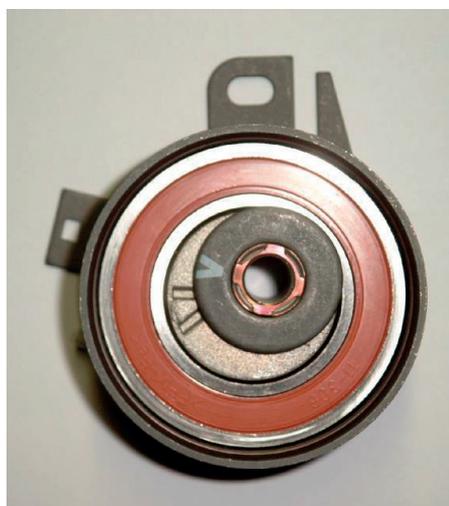
FIG. 1

Fig. 1 tensioner in kit until 08/2004	OE ref. 46792898
Fig. 2 tensioner in kit from 09/2004 until 11/2005	OE ref. 46416489
Fig. 3 tensioner in kit as of 12/2005	OE ref. 71734799

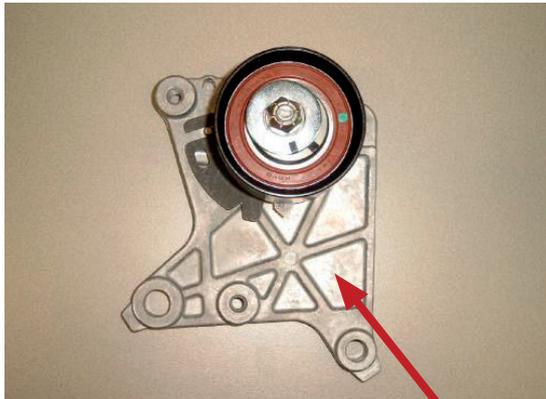
FIG. 4

Fig. 4 and Fig. 5 show the latest version of the tensioner fixed on the bracket.

Normally this bracket (C) is mounted on the engine block and does not have to be removed.

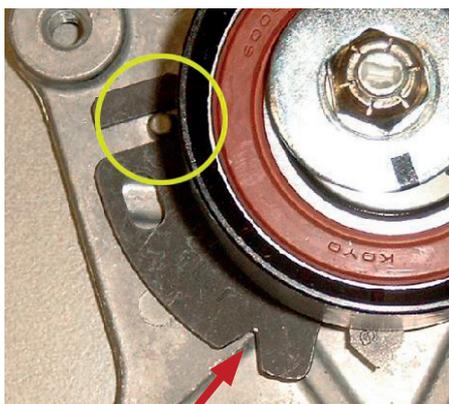
FIG. 6

To lock the tensioner, position the open oblong hole in the base plate of the tensioner on the pin on the bracket (Fig. 6).

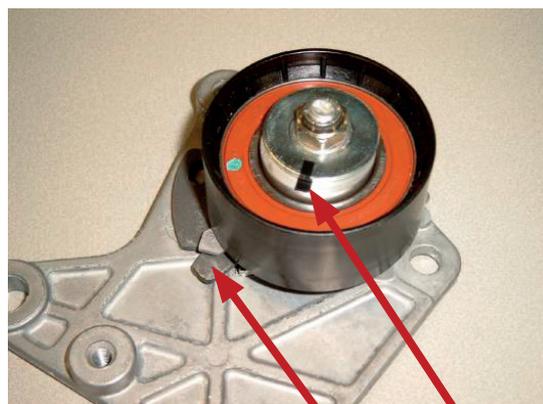
FIG. 7

When the belt and the tensioner are replaced, following the installation instructions inserted in the kit, and after two engine revolutions, the pointer (D) has to be in the middle of the "V" in the base plate of the tensioner (E). At that moment the two black marks (F) will also be aligned. Only then the tensioner is correctly installed.

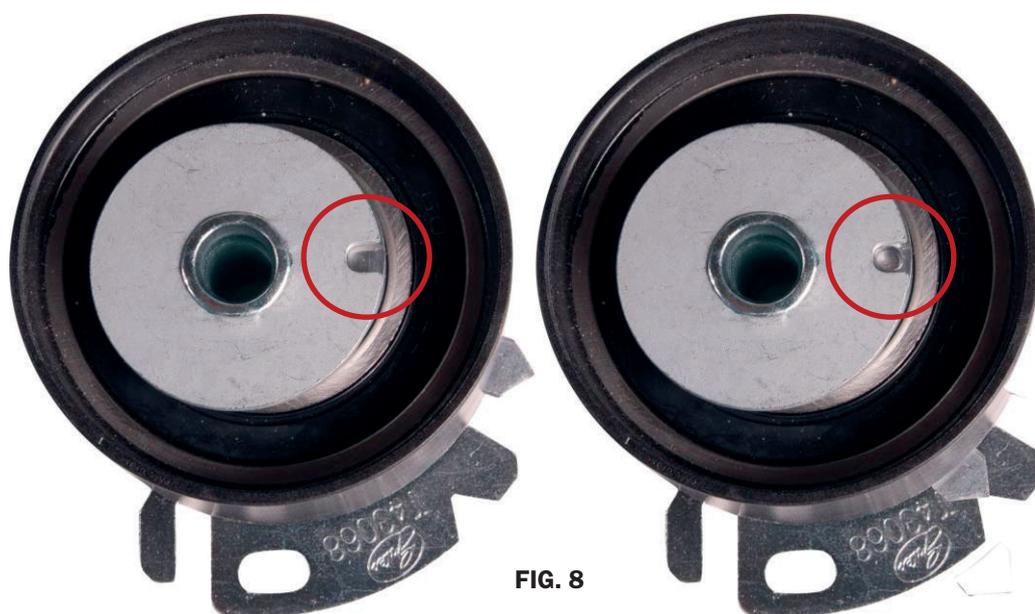
FIG. 8

In the actual kits you find the tensioner (Fig. 8) on which we have changed the black marks into a new positioning system. The indicator of the correct position is a point in relief.

Not in the correct position:

In the correct position:
