TECHNICAL BULLETIN 028

MITSUBISHI & VOLVO 1.8 16V / SYNCHRONOUS DRIVE / TENSIONER INFO

GATES REFERENCE:
5514XS & related kits.

MOTOR CODE:
4G93DOHC, B4184SJ, B4184SM.

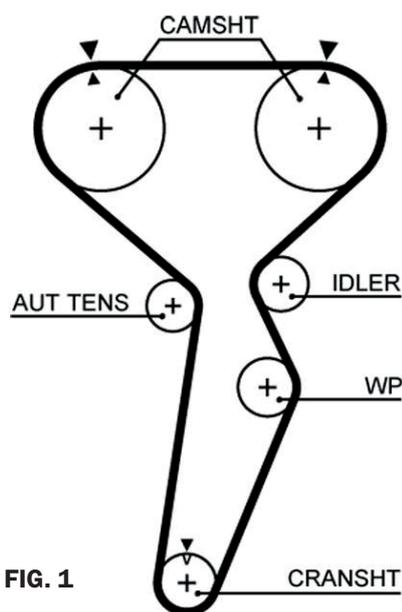
FIG. 1

Fig. 1 shows the drive lay out of this engine, with correct position of the timing marks.

The engine must be at ambient temperature!
 Remove the accessory belt, tensioner/idler pulleys, engine support and timing belt covers.
 Put the engine at Top Dead Centre (TDC), with Timing Marks (TM) aligned (see Fig. 1) by rotating the crankshaft clockwise.
 Lock the 2 camshaft pulleys using GAT4695 and see Fig. 8 for correct positioning.
 Loosen the tensioner pulley bolt then remove the old belt, tensioner pulley and idler.
 By now, the piston rod of the hydraulic tensioner has come out of the tensioner body by 10.5 to 11.5 mm.
 If not, or leakage is present, replace the tensioner.
 Apply a pressure of 10 to 20 Kg on this rod; movement of the rod should be maximum 1 mm. If more, replace the tensioner.

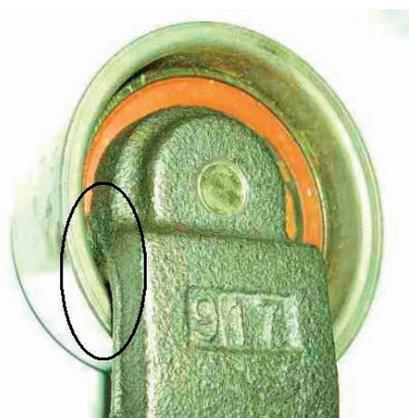
FIG. 2

- 1) Following the recommended tension setting procedure.
- 2) Turning the tensioner in correct direction = anti-clockwise. If not this leads to incorrect tension and very often tensioner seizure. The tensioner bracket touches the pulley, obstructing it to rotate freely (Fig. 2).

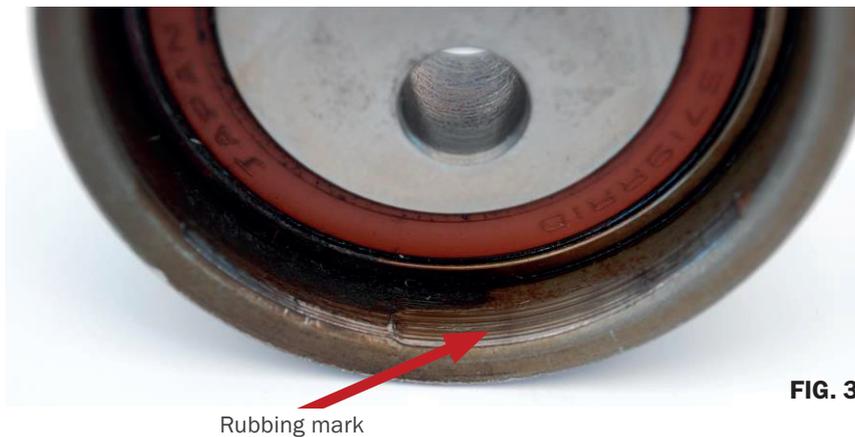
FIG. 3

Evidence of this can be found on the back inner side of the tensioner pulley (Fig. 3).

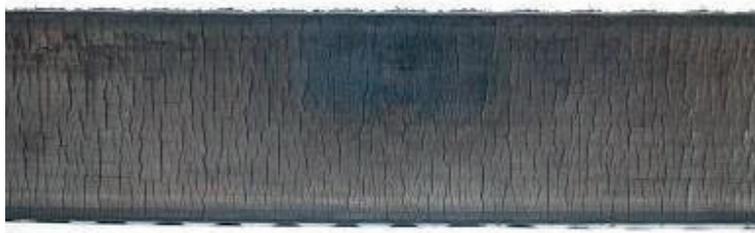
FIG. 4

Since the pulley cannot rotate anymore, the belt back - constantly rubbing against the pulley surface - will start to overheat and crack (Fig. 4).

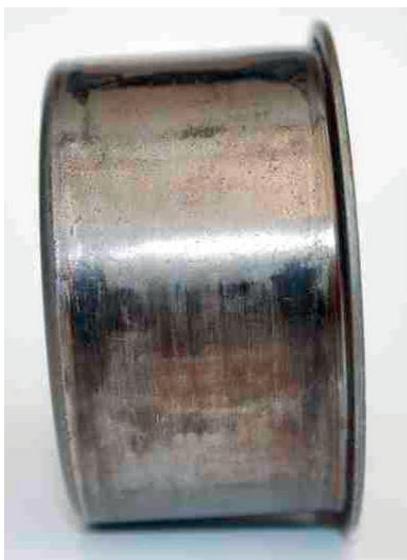
FIG. 5

This excessive temperature is further transmitted to the tensioner and idler pulleys, leaving a blue heat mark on the pulleys (Fig. 5), and possibly even traces of melted rubber (Fig. 6).

In general it is strongly recommended to replace the tensioner and idler pulleys together with the belt, as these parts obviously also wear out. A worn bearing (loss of grease, seizure, misalignment ...) is just as bad as a worn belt, and will lead to premature drive failure, resulting in serious engine damage.

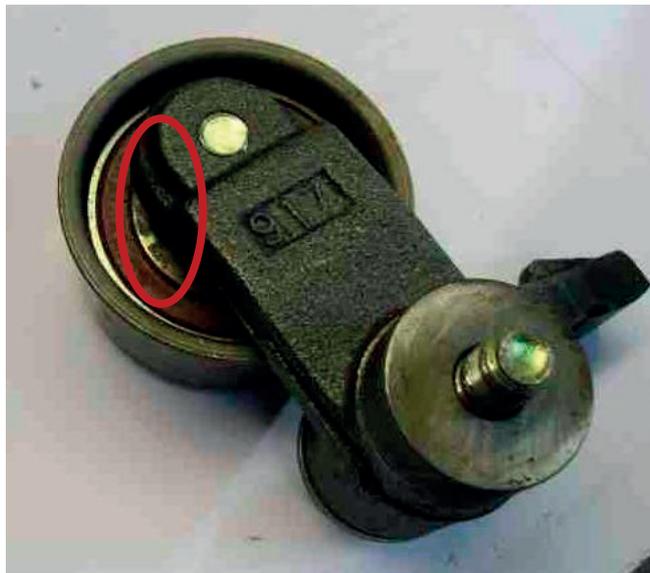
FIG. 7

If the tensioner pulley is turned in the correct – anti clockwise - direction, it will not be able to come into contact with the bracket (Fig. 7).

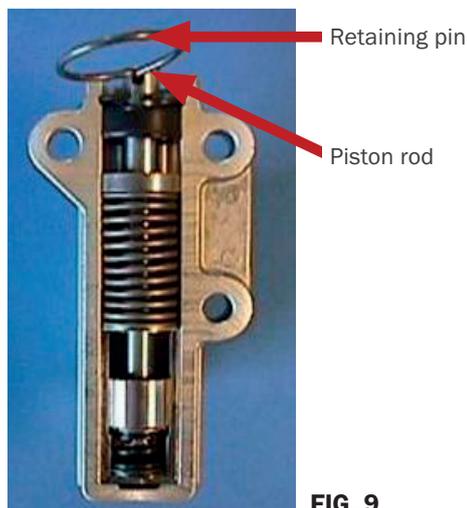
FIG. 9

Push the rod slowly down (vertically) until the holes of the rod and the tensioner body are in line. Insert a 2 mm retaining pin (can be found in GAT4657) (Fig. 9).

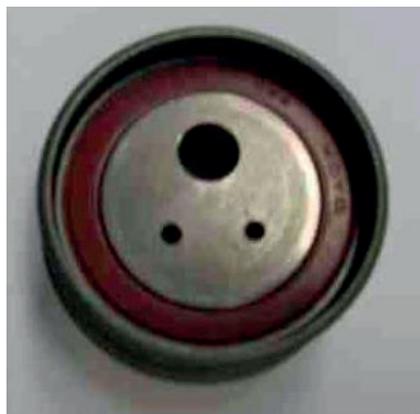
FIG. 10

Install the new tensioner and idler pulleys (tensioner pulley with eccentric hole at the top, 2 small adjusting holes at the bottom) (Fig. 10).

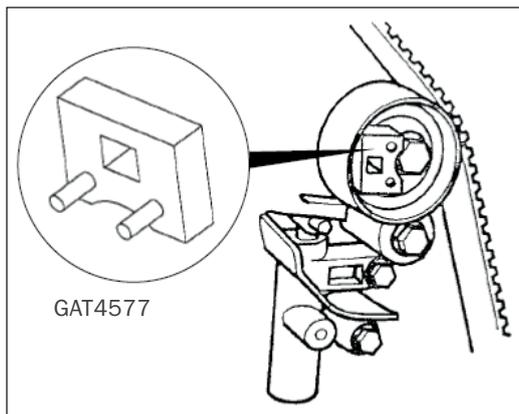
FIG. 11

Turn the tensioner pulley (using adjuster GAT4577 included in GAT4657) ANTICLOCKWISE into the belt and tighten the bolt (Fig. 11).

Turn the tensioner pulley (using GAT 4577 and a torque wrench) ANTICLOCKWISE towards the belt, with a force of 2.5 to 4.0 Nm.

Tighten the tensioner pulley bolt (50 Nm).

Pay attention: keep the pulley in place while torqueing the bolt!
