TECHNICAL BULLETIN 027

29/04/2009

FORD 1.8 D / SYNCHRONOUS DRIVE / INSTALLATION INFO

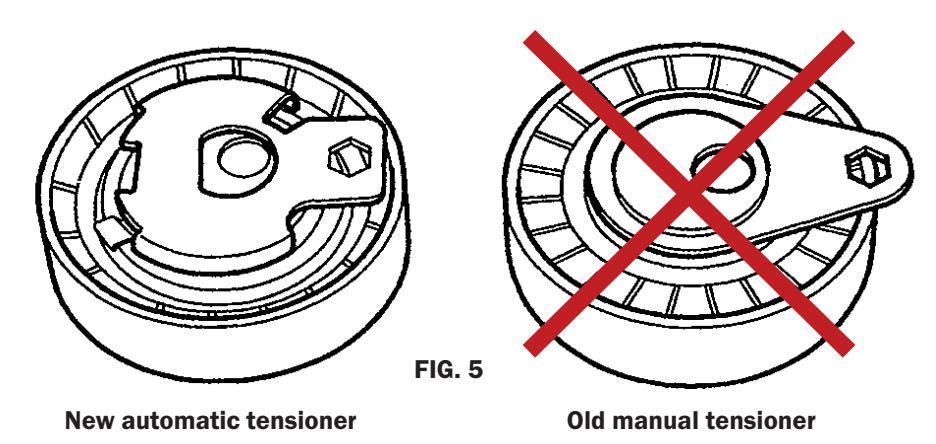
Fig. 5 shows the initial manual tensioner on the right side and the current automatic tensioner on the left.

When the manual tensioner is replaced by an automatic tensioner, the timing belt cover has to be slightly modified.
