TECHNICAL BULLETIN 032

ALL / ACCESSORY DRIVE / INSTALLATION INFO

GATES REFERENCE:
All V-and Micro-V® belts.

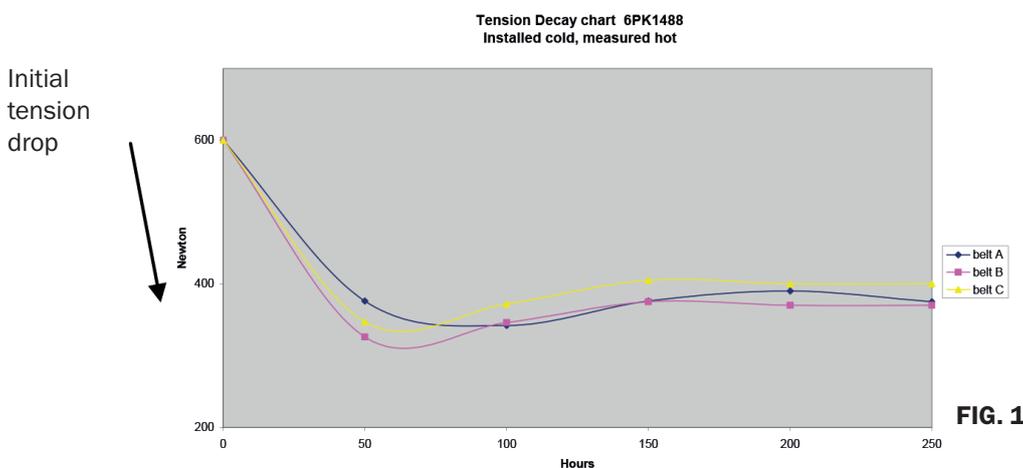
As there is no automatic tensioner to control the tension of the belt over its expected lifetime, the installation tension on fixed systems has to take into account the initial tension drop over the first days of functioning on the drive (Fig. 1).

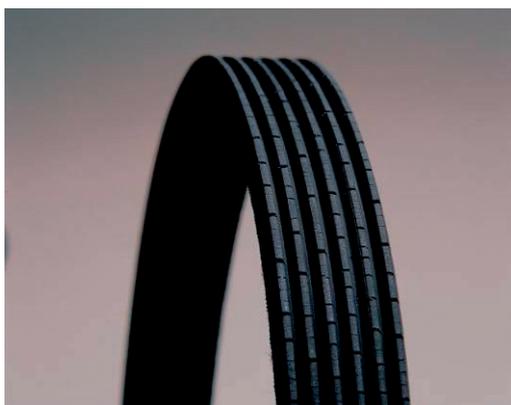
FIG. 2

- Too high tension will lead to abnormal wear, extreme heat build-up, rubber hardening and cracks (Fig. 2), premature cord break and noise.
- Too low tension will lead to slippage (insufficient tension to drive the different components), noise, extreme heat build-up, rubber hardening/cracks, belt rupture and pulley wear. Belts which have been slipping will show shiny flanks, on both sides of the belt/rib (Fig. 3).

Recommended static installation tension:

New belt	Used belt
AV10	350N (35 Kg)	270N (27 Kg)
AV13	500N (50 Kg)	350N (35 Kg)
Micro-V®	100N (10 Kg) / rib	60N (6 Kg) / rib

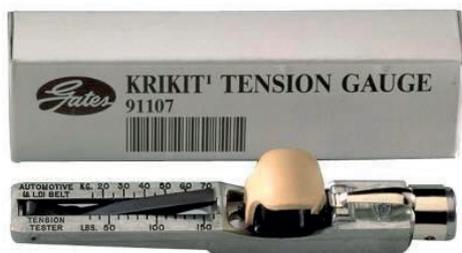
FIG. 4

- Kriket I (7401-00071) (Fig. 4) is ideal for measuring the tension of V-belts, this tool can also handle narrow Micro-V® belts
- Kriket II (7401-00072) (Fig. 5) is a simple tool for measuring tension of wider Micro-V® belts.
- However, for vehicles with a more sophisticated drive on modern engines, Gates offers the Sonic Tension Tester STT-1 (7420-00301) (Fig. 6), which was initially developed for checking the tension of Timing Belts. This very accurate tool can also be used for checking the tension of all Micro-V® belts tensioned with a manual tensioner. It allows to make a distinction between new and used (run in) belts.

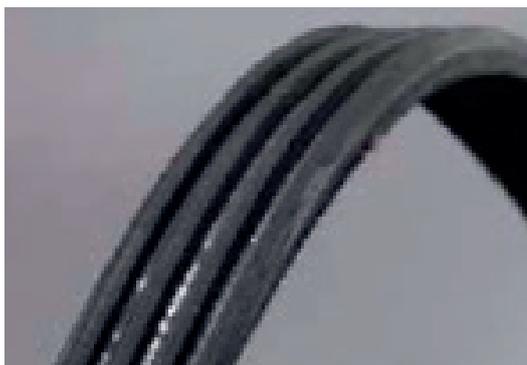
FIG. 7

- Pilling: As the ribs do not enter perfectly into the pulley grooves, particles of rubber are worn away from the rib sides. These particles are pushed together in the belt grooves, forming little rubber balls which will create noise (Fig. 7).
- Damaged outside ribs: The outside rib which is running into the pulley flange gets damaged and can come loose (Fig. 8). Also the tensile cord could be pulled out of the belt. These loose ribs/cords create a very dangerous situation: they could enter into the timing belt system resulting in an engine breakdown.
- Noise: The ribs not entering straight into the pulley grooves can lead to belt noise.

If misalignment is the problem, our DriveAlign® laser (7468-00113) (Fig. 9) will allow you to determine which pulley is misaligned. It is clear the alignment problem should be solved before installing a new Micro-V® belt!

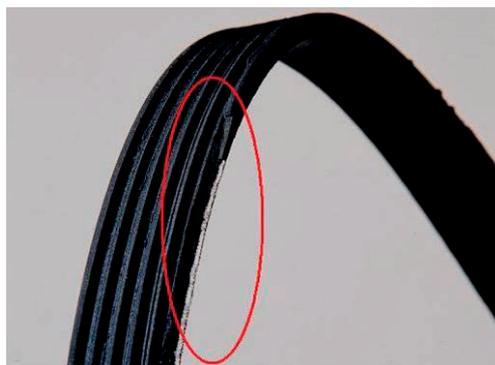
FIG. 8

Belts running misaligned will have a shiny aspect on one side of the ribs.

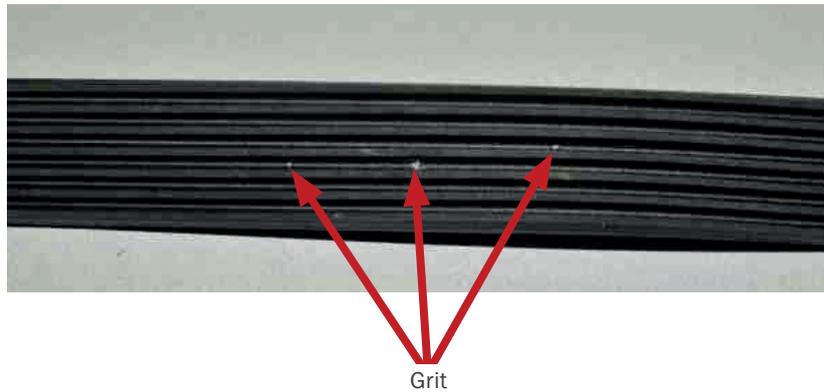
FIG. 10

Little stones in between the belt ribs (Fig. 10) can be a reason for noise. These can be found via a visual inspection.
